Study of coastal abrasion disasters and their causes in Pariaman City

Haryani^{1,*}, Agus Irianto² and Nurhasan Syah²

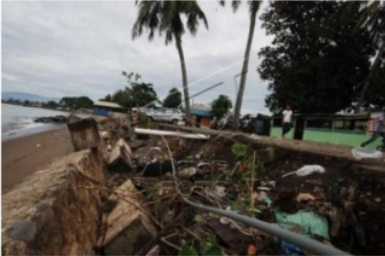
<p>Figure 2. Abrasion January 2017</p> <p>breakwater stones need Rp. 30 billion</p>

<p>2014</p>	<ul style="list-style-type: none"> • coast of Nareh Beach, North Pariaman District 	<p>BNPB provided assistance of Rp 30 billion for the installation of breakwater stones</p>
<p>2013</p>	<ul style="list-style-type: none"> • coast of Nareh Beach, North Pariaman District 	<p>BNPB provided assistance of Rp 40 billion for the installation of breakwater stones</p>
