Study of coastal abrasion disasters and their causes in Pariaman City

Haryani^{1,*}, Agus Irianto² and Nurhasan Syah²

¹Doctor Programe of Environmental Science, Padang State University and Faculty of Civil Engineering and Planning, Bung Hatta University, Padang City, Indonesia

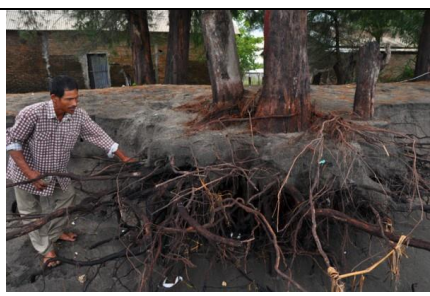
<p>Figure 1. Abration October 2017</p>	<ul style="list-style-type: none"> • APBD Amendments and central government assistance in installing breakwater stones at some points. • the local community was also asked to work together to build a temporary embankment
11/1/ 2017	<ul style="list-style-type: none"> • abrasion of Gandoriah Beach, Anas Malik Beach, Angso Duo Island, Kasiak Island and Nareh Beach in North Pariaman District • Gandoriah Beach to Anas Malik Beach which is located in the District of Central Pariaman is approximately affected by abrasion around 35 to 40 meters • tourism facilities and infrastructure that have been built are also threatened (Development of Anas Malik Park area, Republic of Indonesia Navy Monument, ASEAN Monument, and a number of other tourist parks) • beach abrasion that occurs is predicted to be purely due to natural phenomena due to extreme weather • Around 500 meters of Nareh Beach's lips have not been protected

10/10/2017	<ul style="list-style-type: none"> • abrasion on the Nareh coast of North Pariaman District • abrasion along the coast of Padang Biriak-Biriak Village, North Pariaman Subdistrict, residents are quite dense. • “Pasia Maelo”; land ownership rights or beaches that become land are threatened with loss • some of the land around the shoreline is certified, if the abrasion continues to expand then the ownership rights are automatically lost • 12 houses were abrasion • has eroded up to 80 meters inland • only two breakwater stones have been installed, at least need seven.

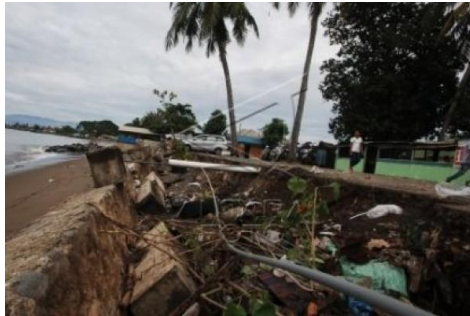
<p>Figure 2. Abration January 2017</p>	<p>breakwater stones need Rp. 30 billion</p>
